Case Study II

Performance of Extruder Distilled Water Coolants

Background. A Case Study II. A new sheet extrusion and thermoforming facility with four single screw water-cooled co-extrusion lines, was commissioned using commercially available distilled water as the barrel zone coolant. System metallurgies were similar to those previously noted.

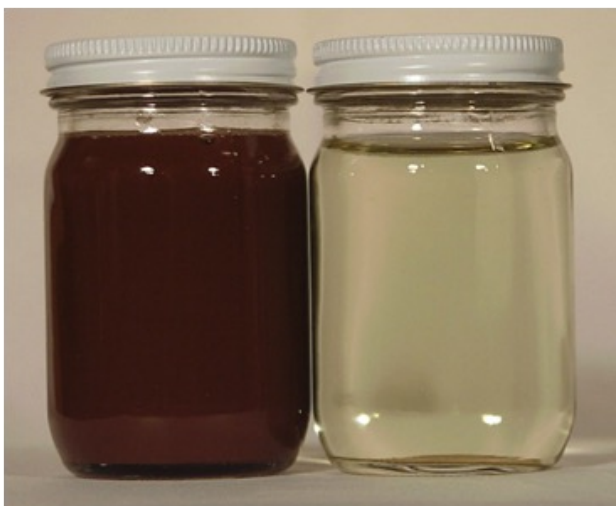
Figure 5. Fouled extrusion system distilled water coolant (left) and one maintained with EPF (right).

To restore these systems to optimum operating condition, each extruder cooling water system was thoroughly cleaned and flushed with a proprietary organic-based chemical descaler, followed by several flushes with tap water, and concluding with at least one high-purity water flush. After each system was cleaned following this procedure, it was charged with Extrusion Performance Fluid, a water-based, all-organic corrosion and deposit inhibition coolant. Typical 'before-and-after' coolant clarity is illustrated in Figure 5.
